# Portage Creek Sediment Remediation Project Kalamazoo, Michigan

## Pre-Sediment Removal Structure Feature Assessment Removal Areas SA3-A, SA3-B and SA3-Access

F&V Project Number: 809930  
August, 2012

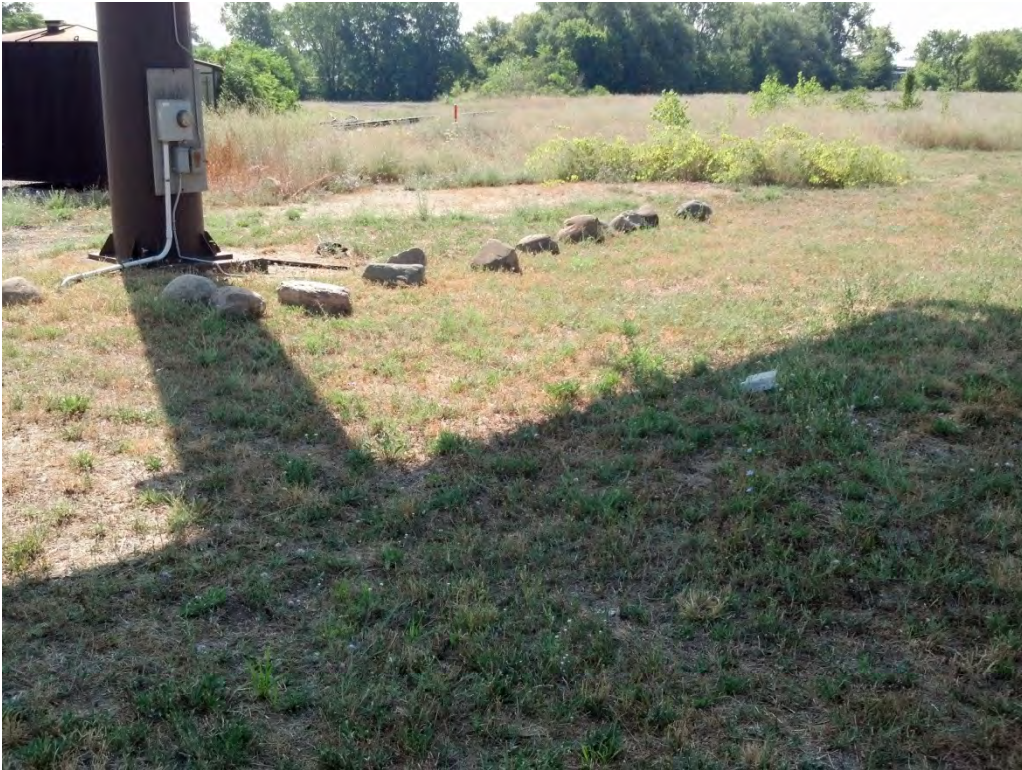
View of area looking southeast

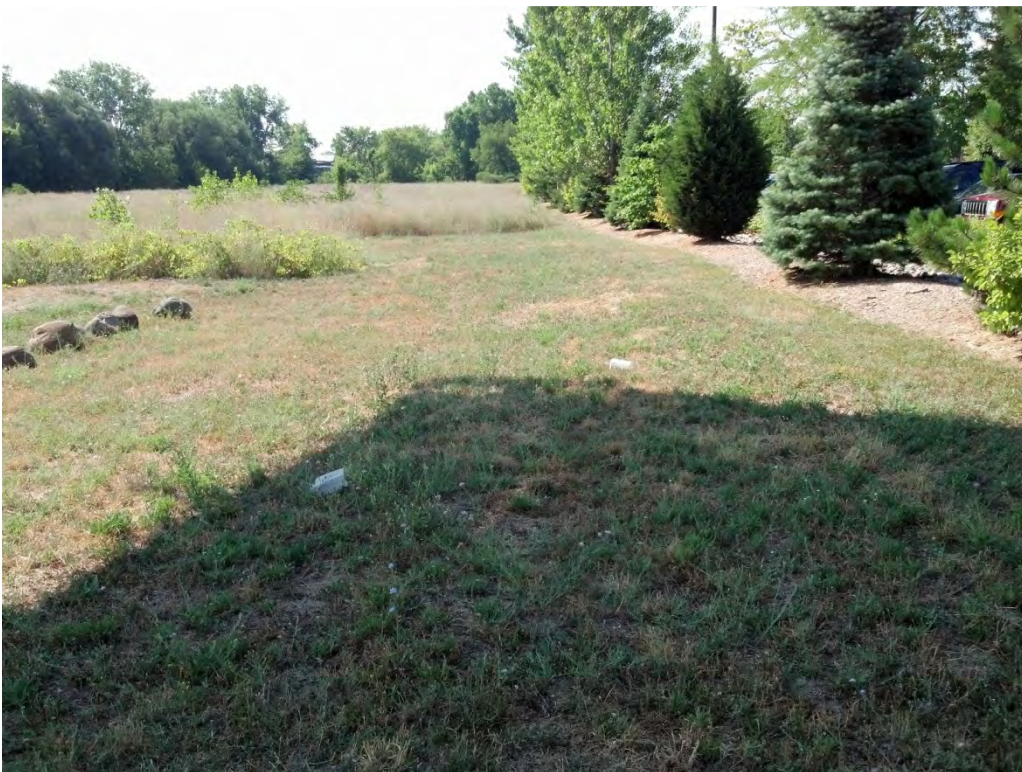
View of field along parking lot landscaping looking south

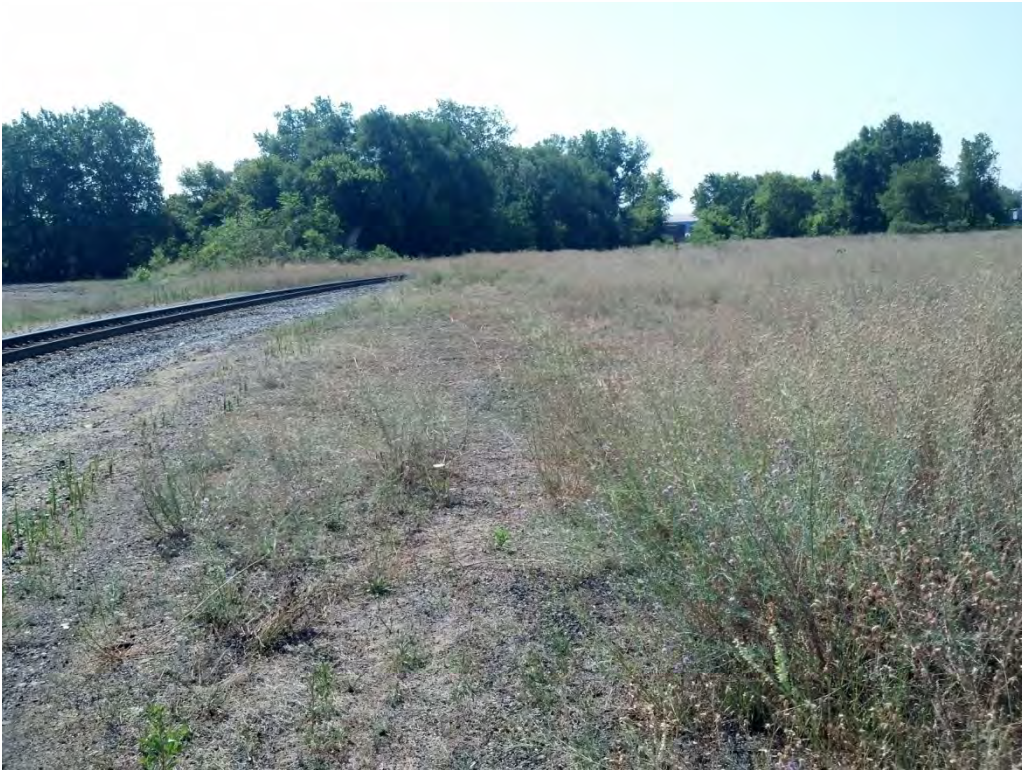
View of east side of area looking south

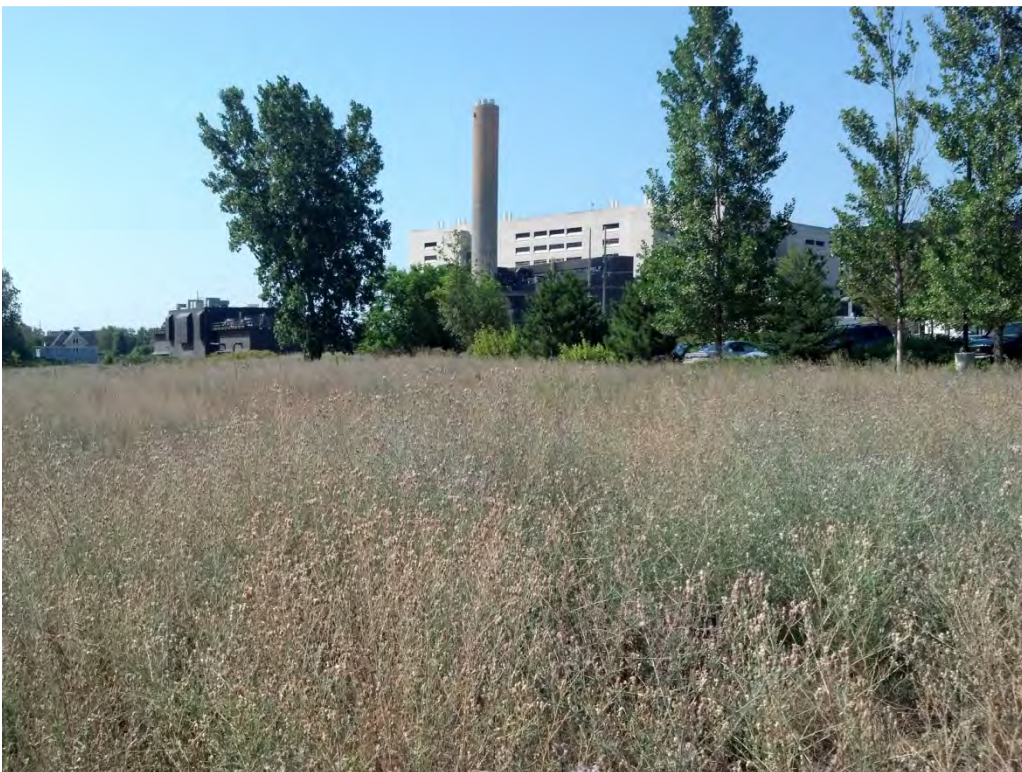
View of area looking southwest

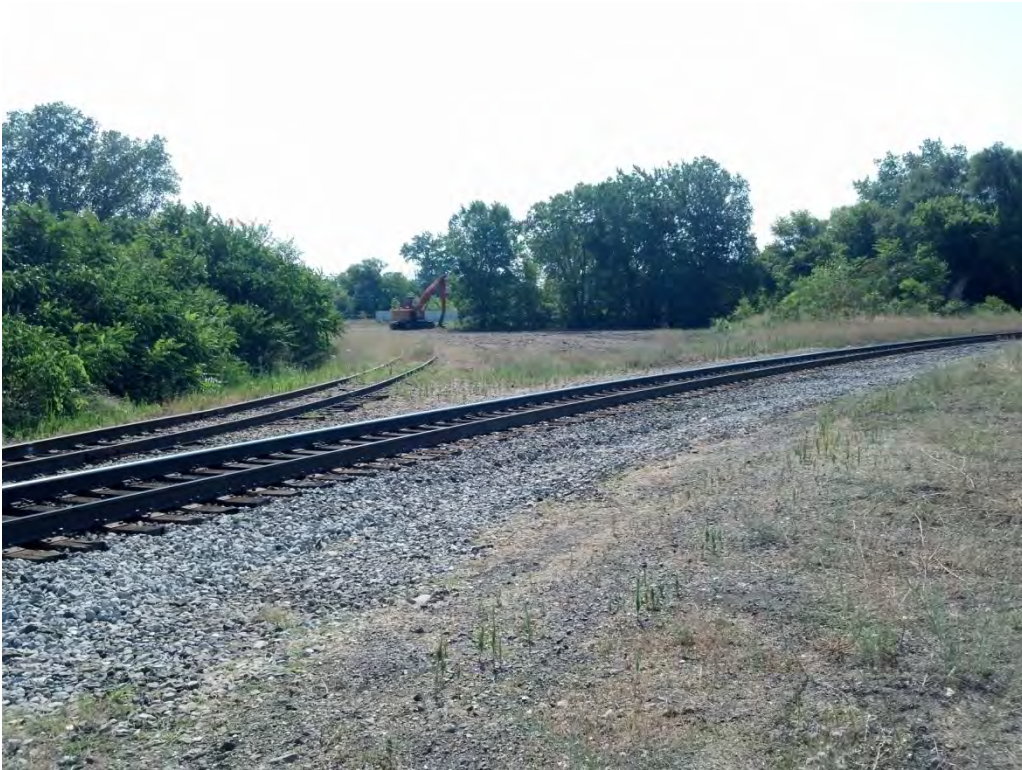
View of east side of area looking southeast

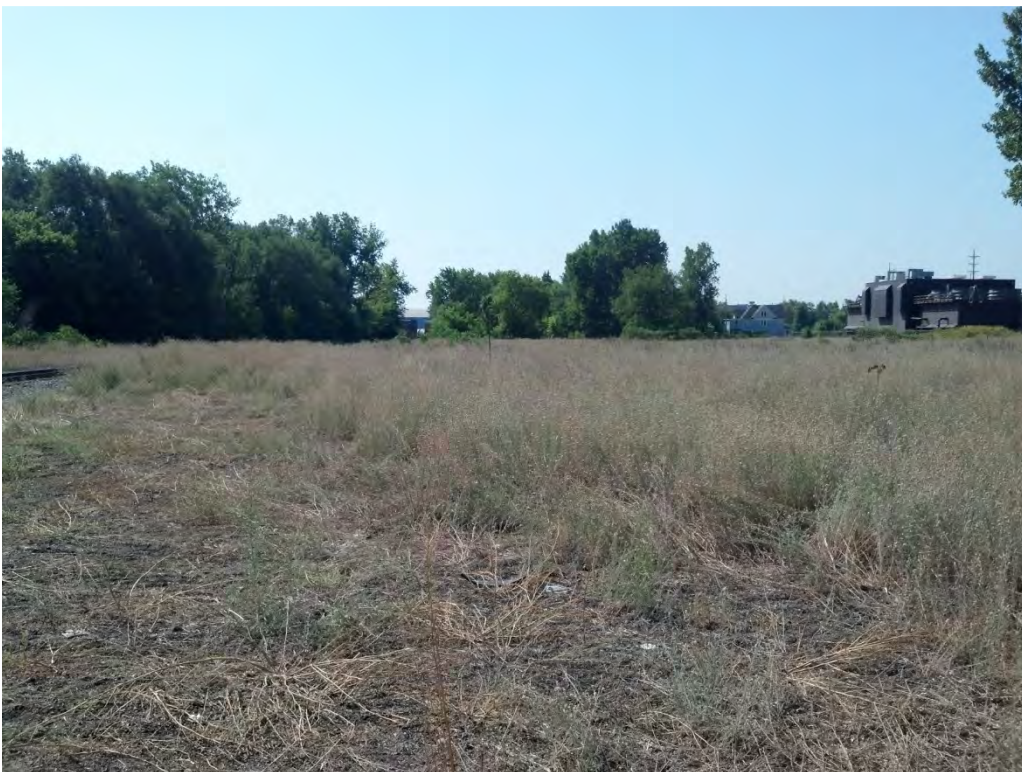
View of area looking south

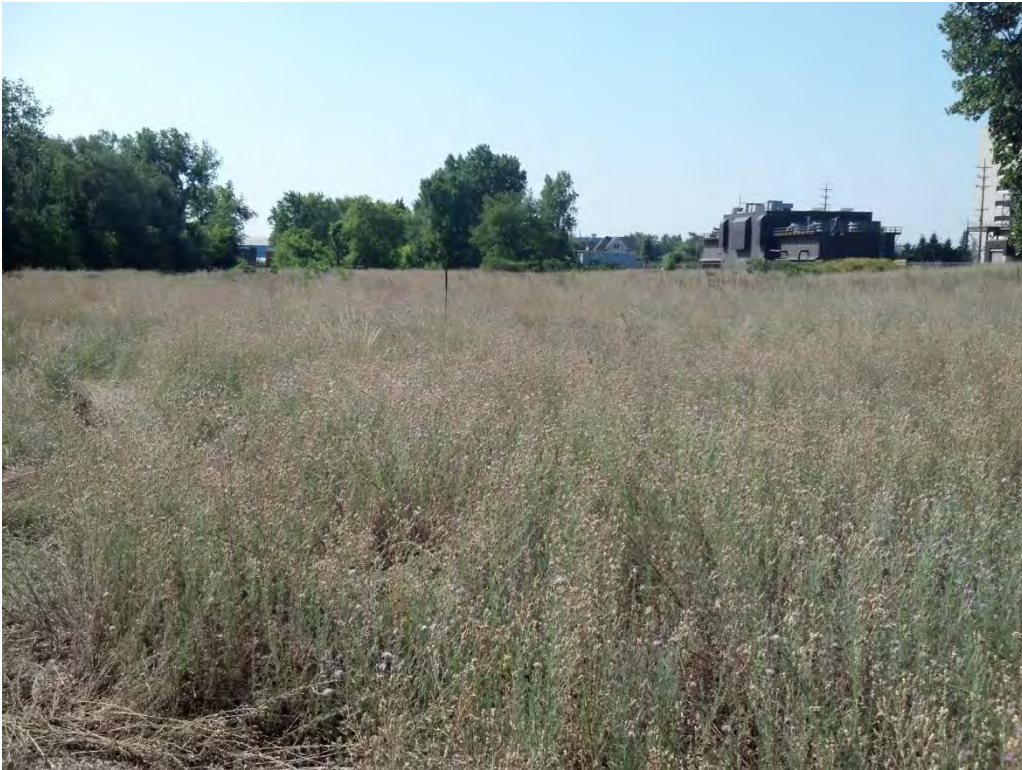
View of area looking south

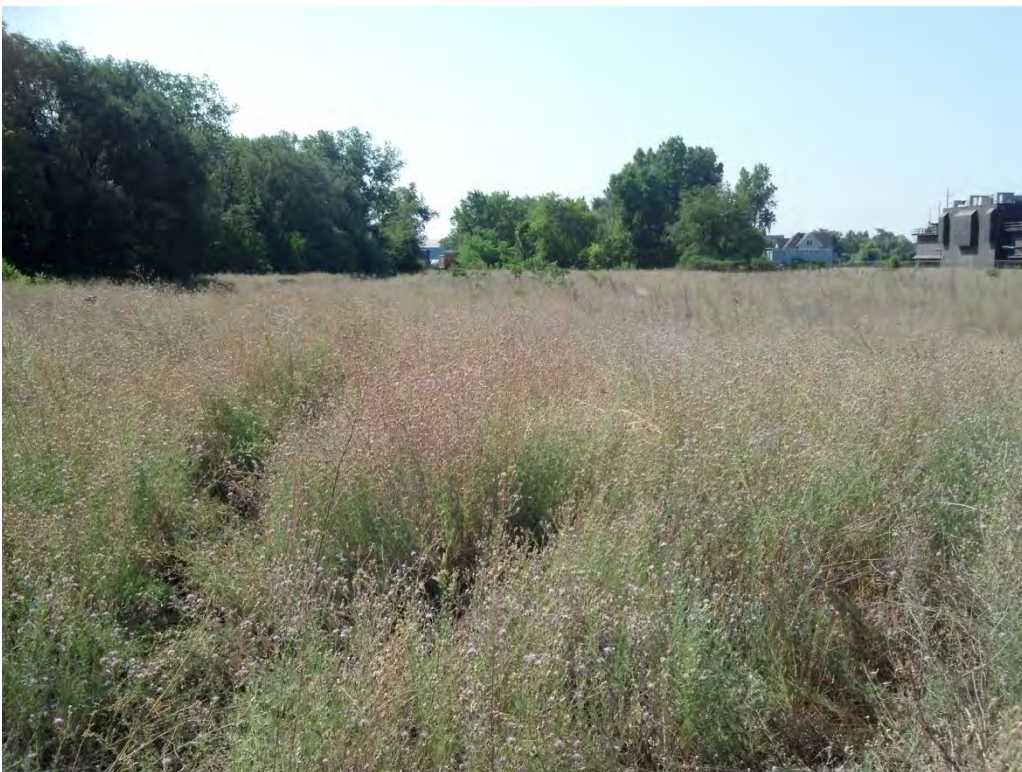
View of area SA3-A from field

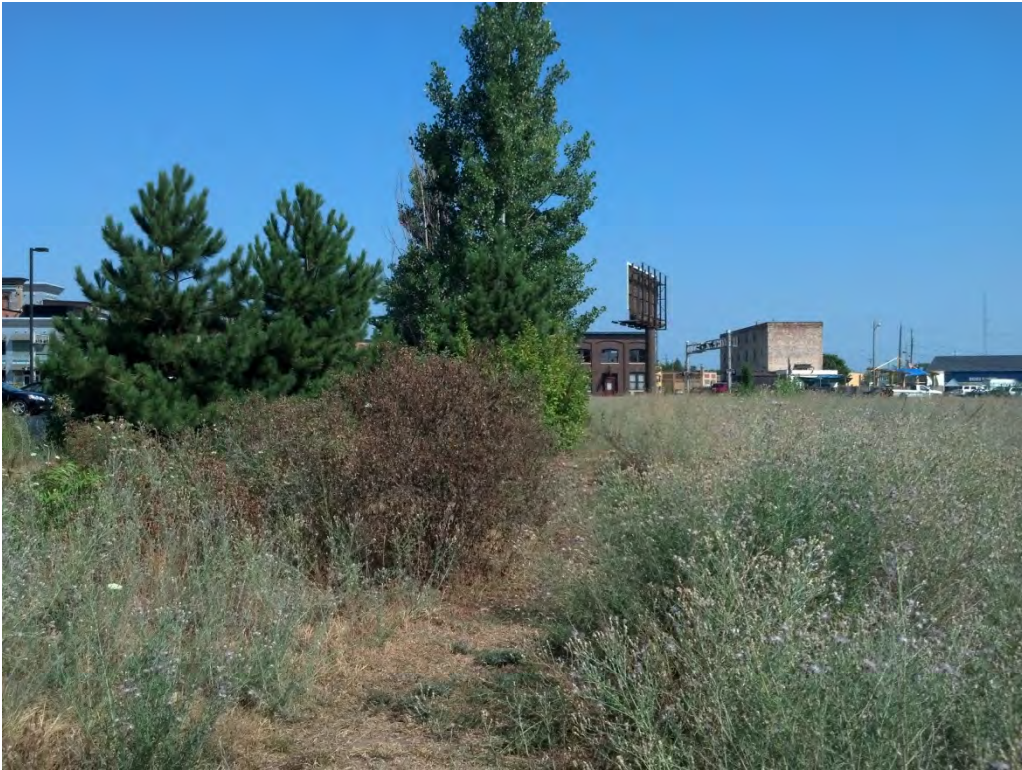
- The parking lot is fairly new and in good condition.

Landscaping southeast of parking lot

- The parking lot and landscaping should be identified/protected with construction fencing or similar during the work.

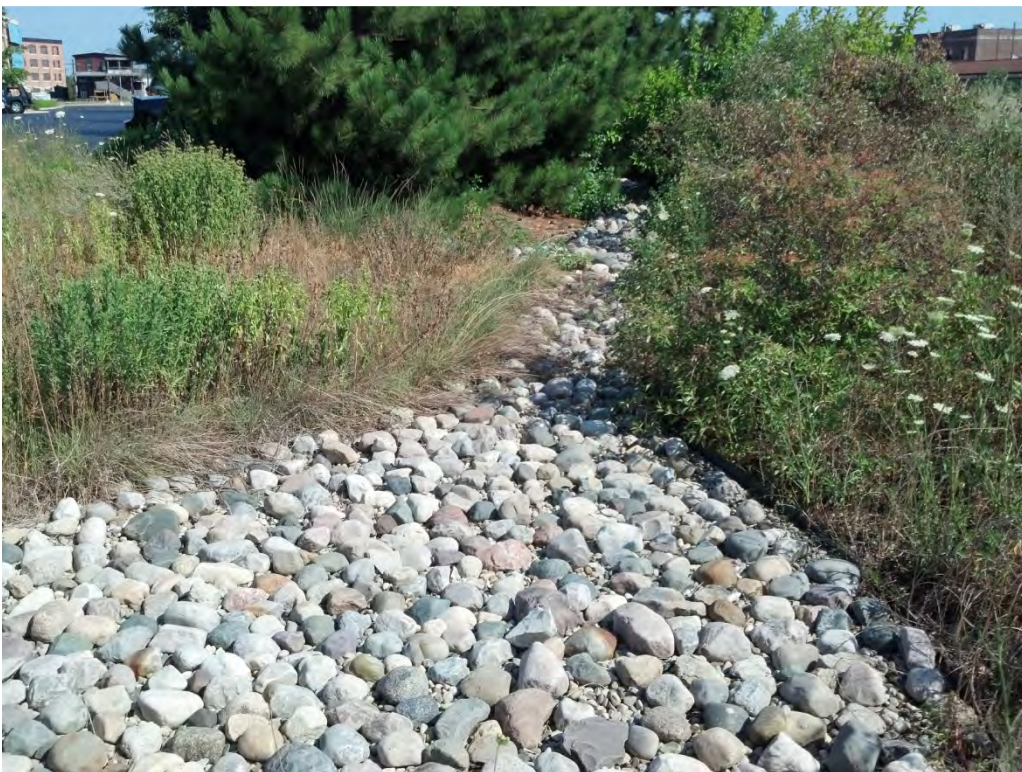
Drainage swale southeast of parking lot

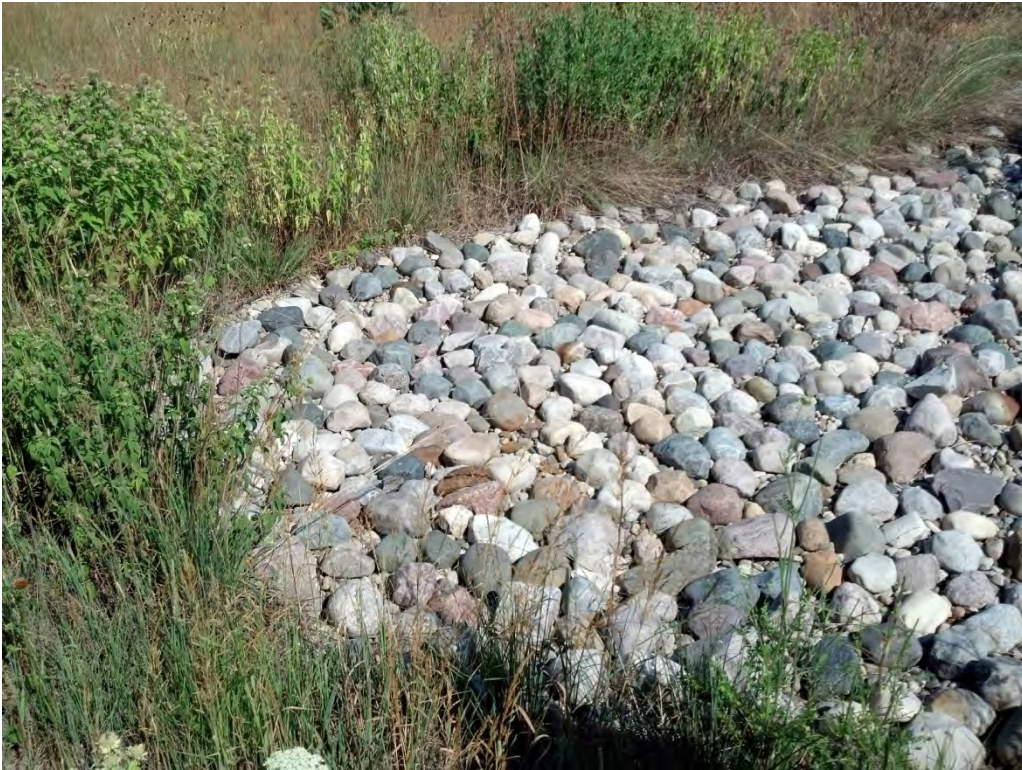
Leaching area southeast of parking lot

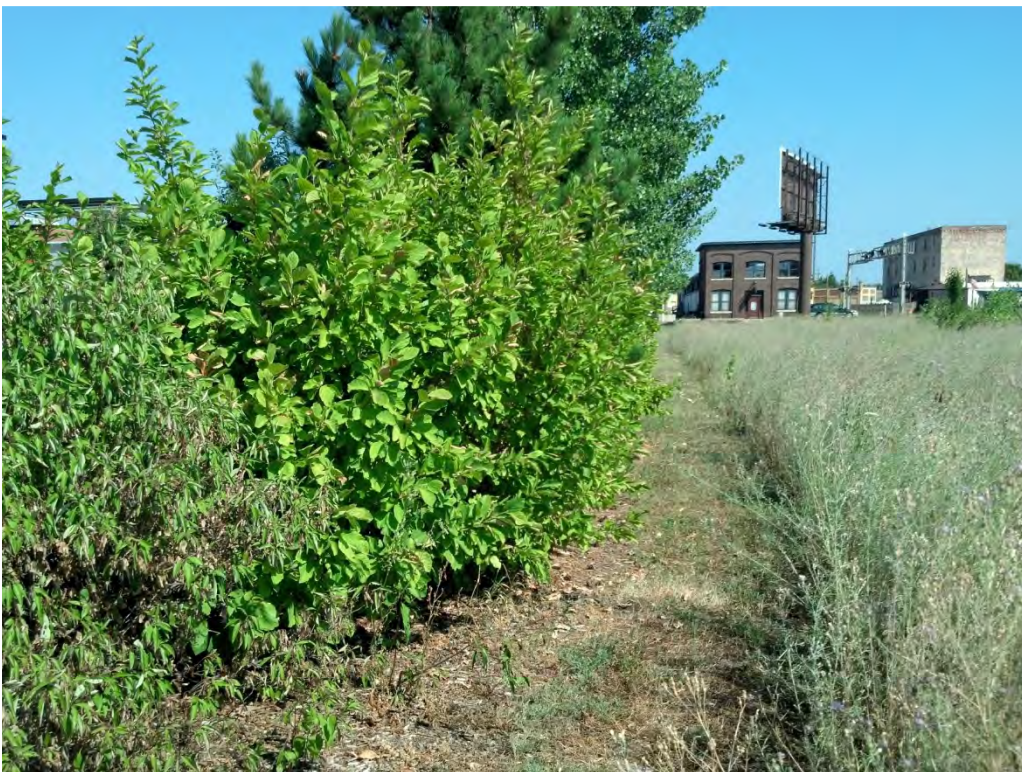
Landscaping along east side of parking lot looking north

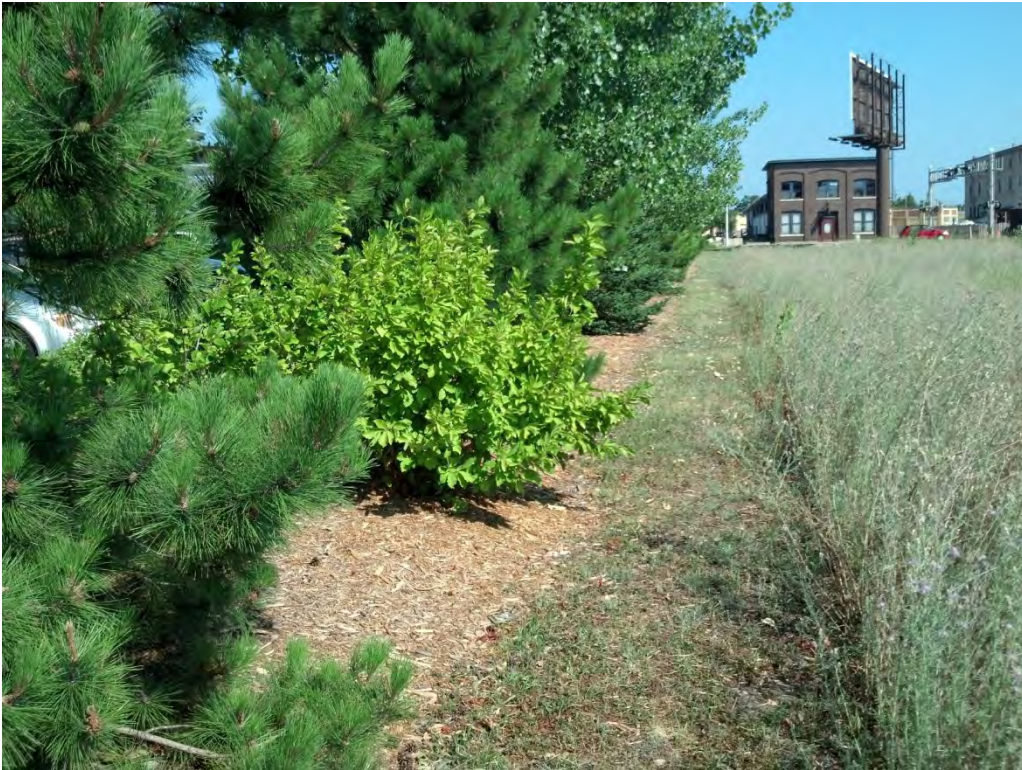
Landscaping along east side of parking lot looking north

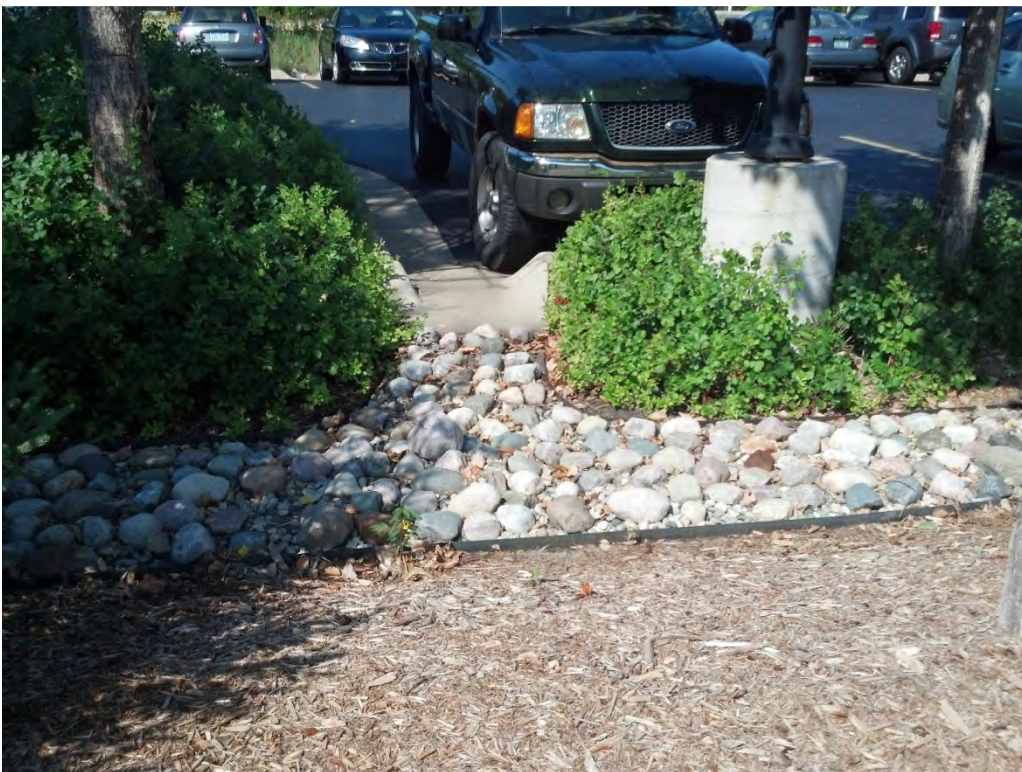
Concrete curb outlet into drainage swale

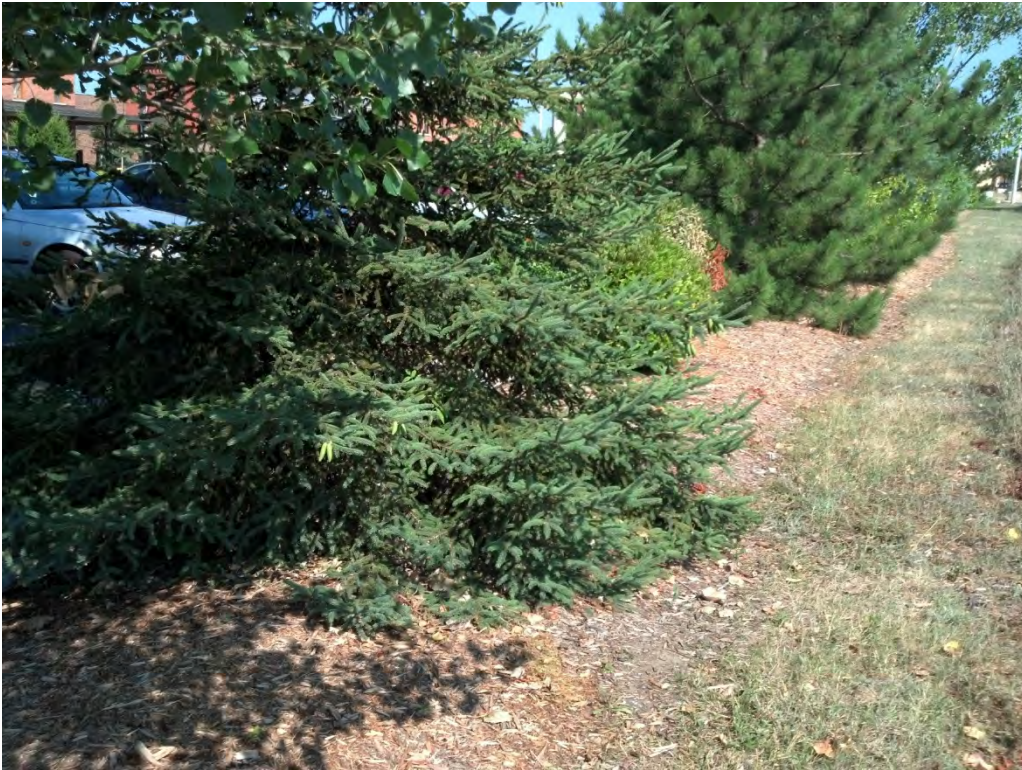
Landscaping along east side of parking lot looking north

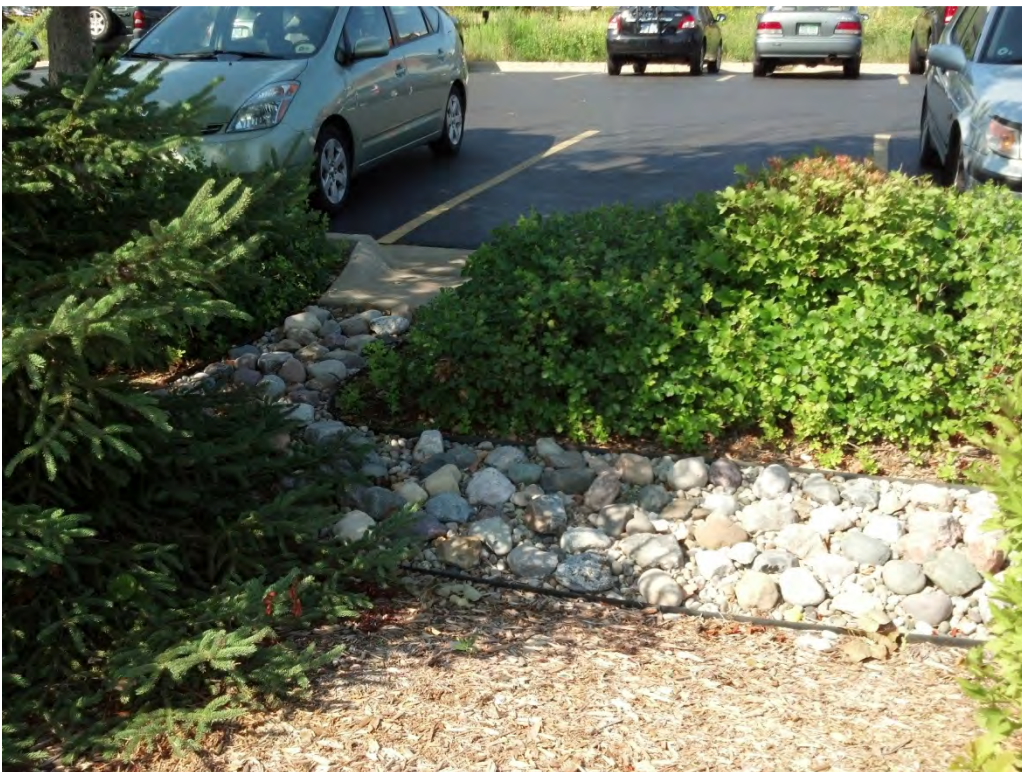
Concrete curb outlet into drainage swale

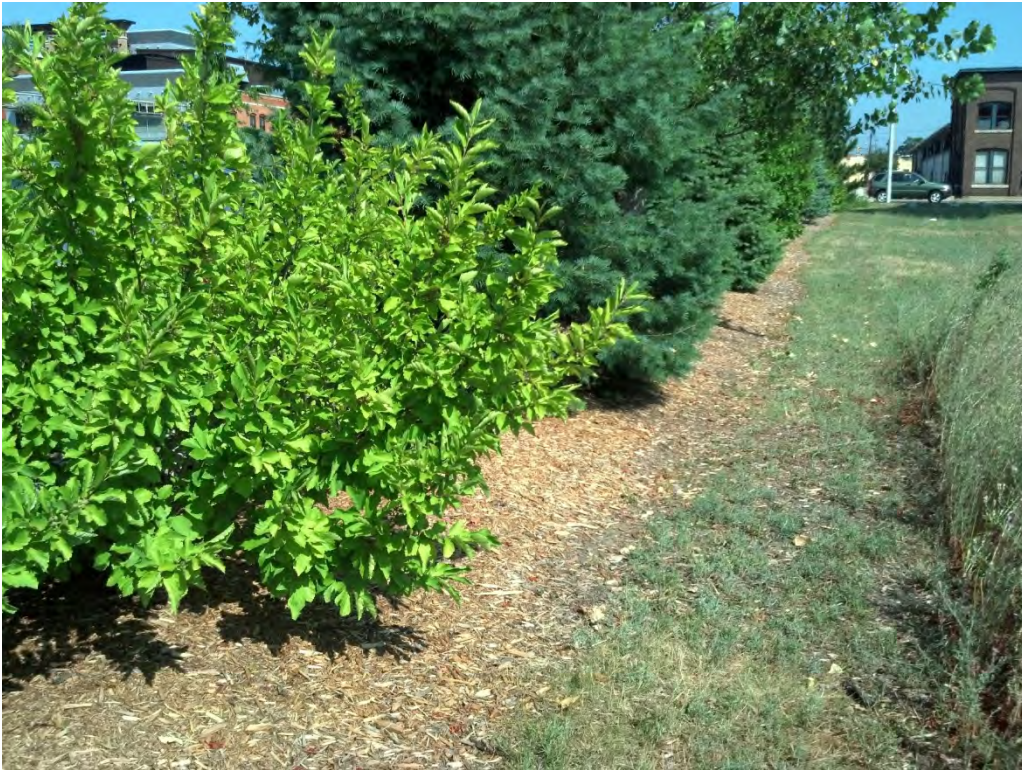
Landscaping along east side of parking lot looking north

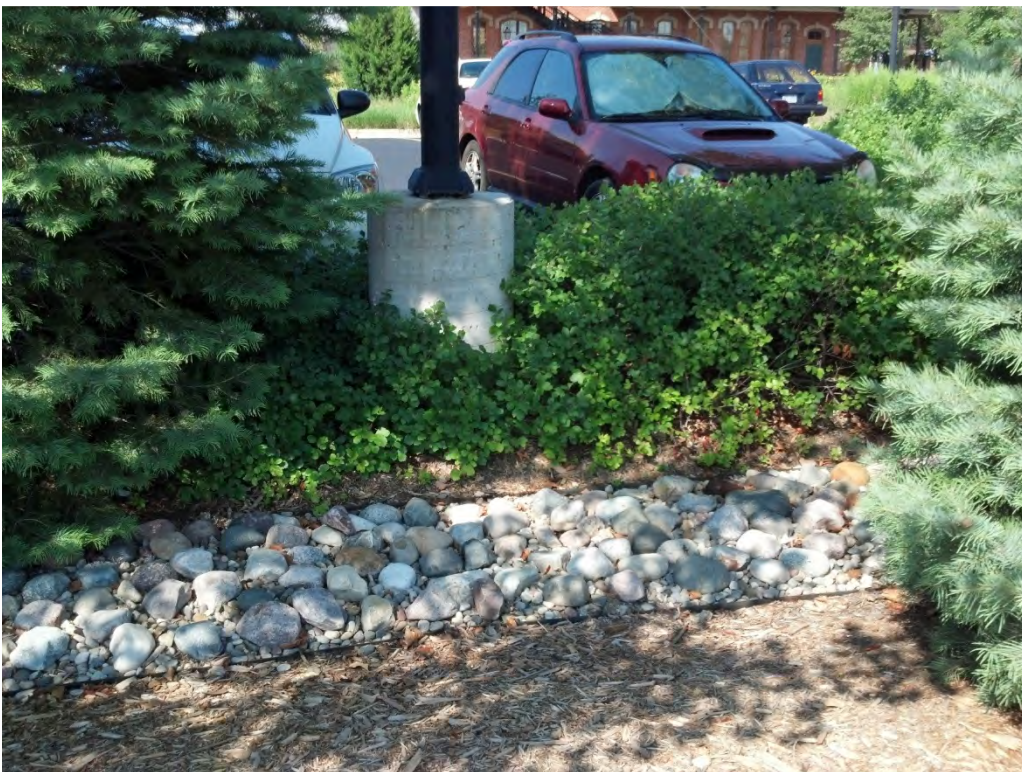
Drainage swale and concrete light base along east side of parking lot

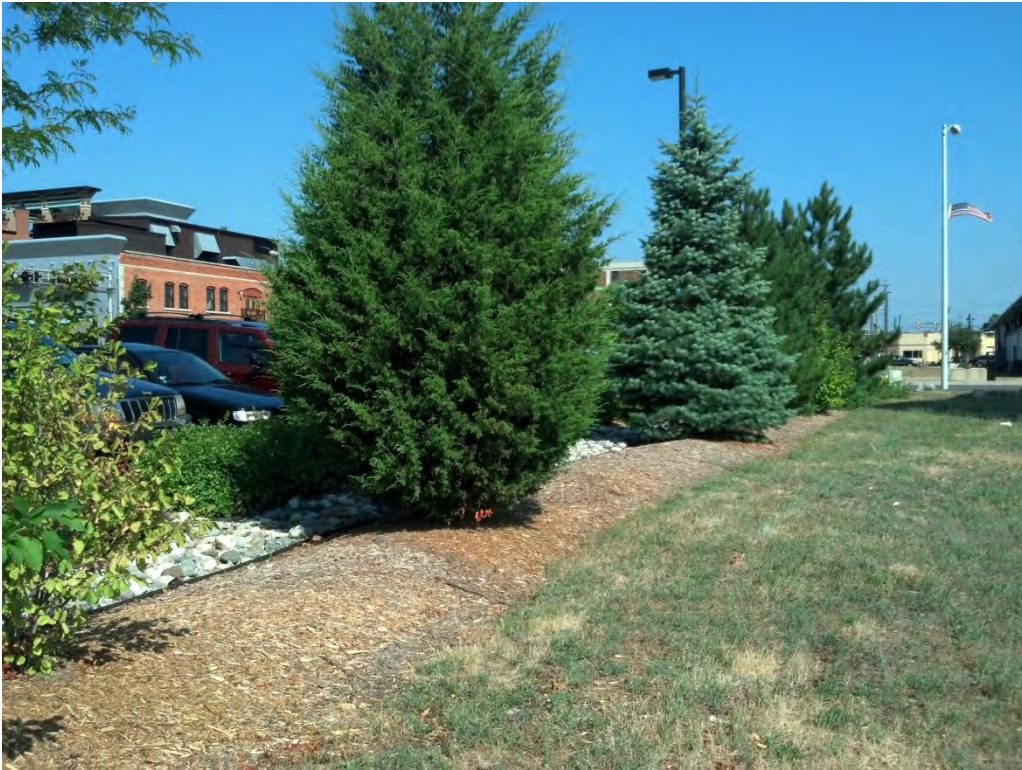
Landscaping along east side of parking lot looking north

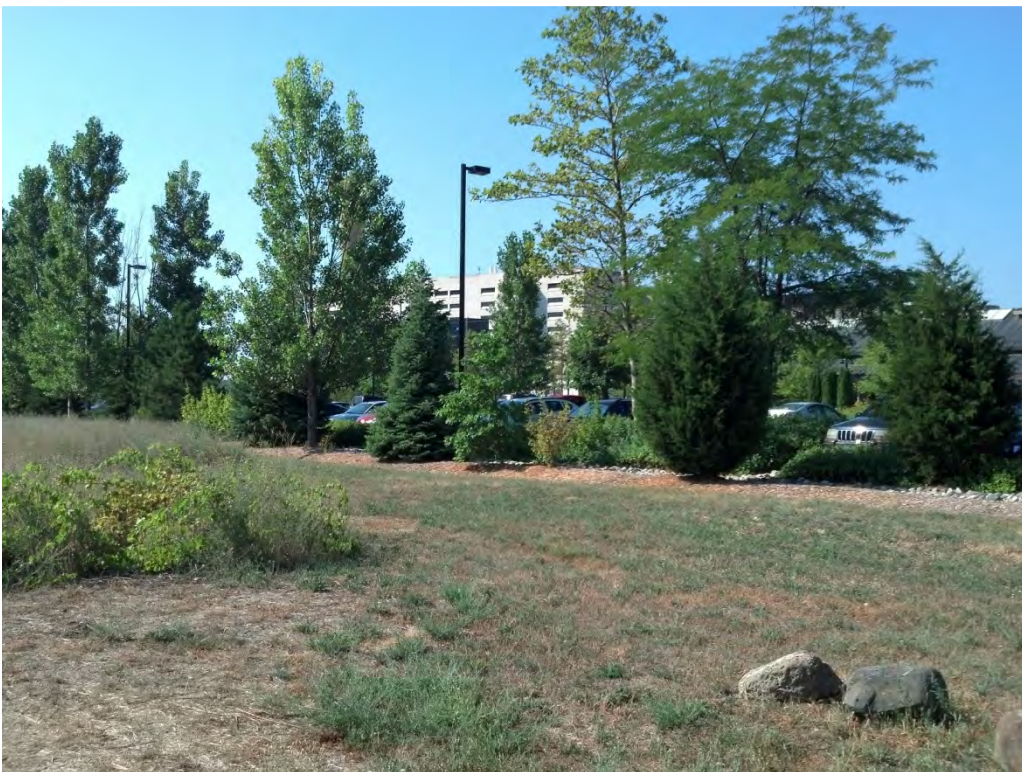
View of landscaping along east side of parking lot looking southwest

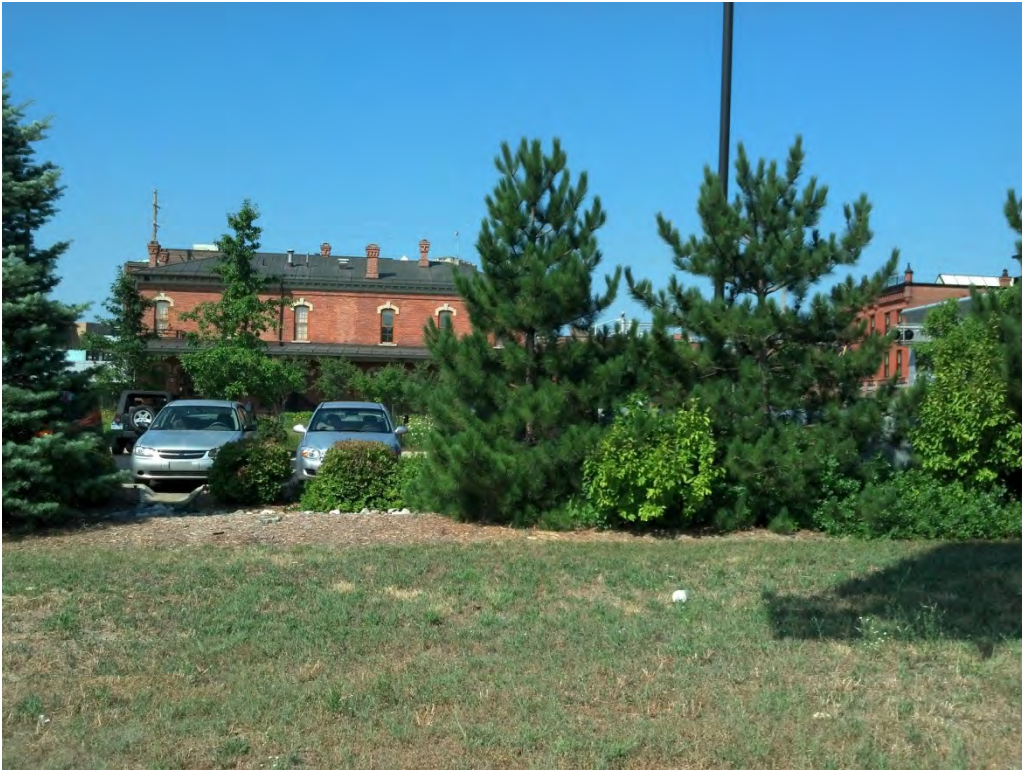
View of landscaping along east side of parking lot looking west

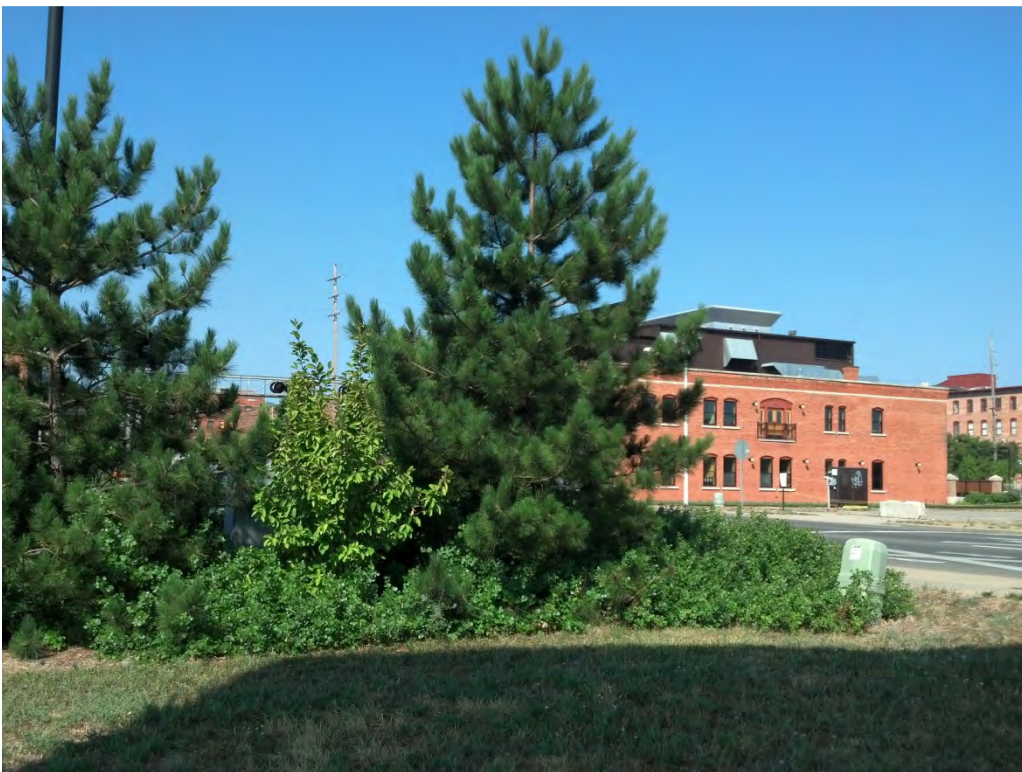
View of landscaping along east side of parking lot adjacent to East Michigan Avenue

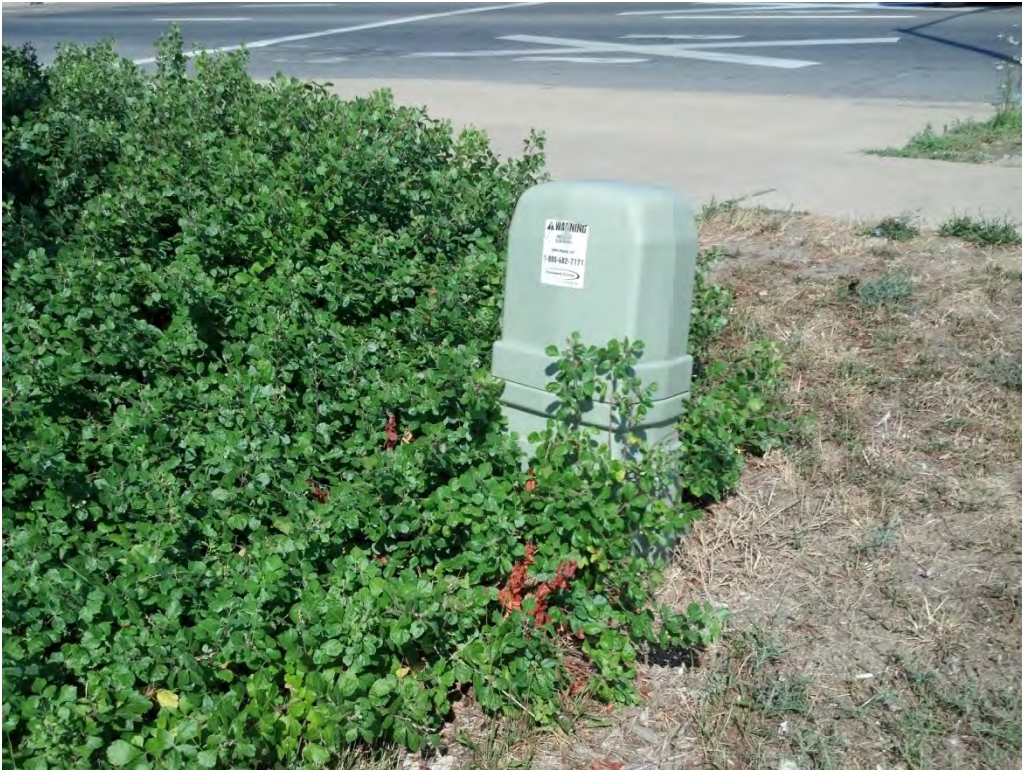
- The pedestal appears to be in good condition, however it leans to the north significantly.

View of pedestal looking north toward East Michigan Avenue

- The pedestal should be identified/protected with construction fencing or similar during the work.

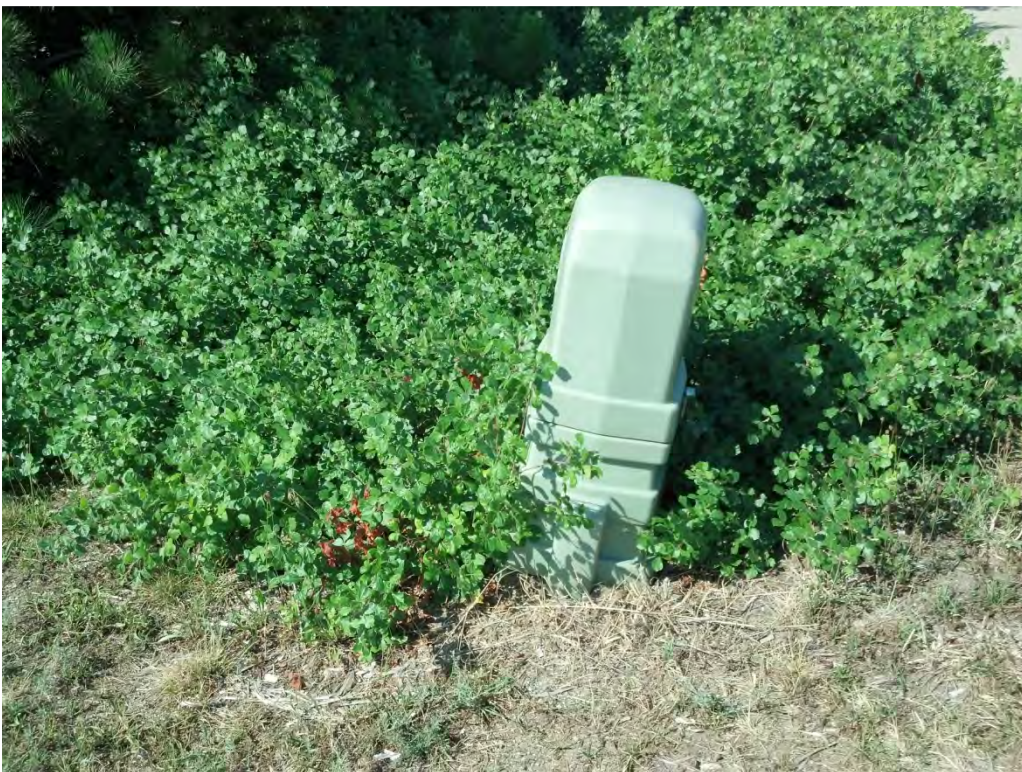
View of pedestal looking west showing northward lean

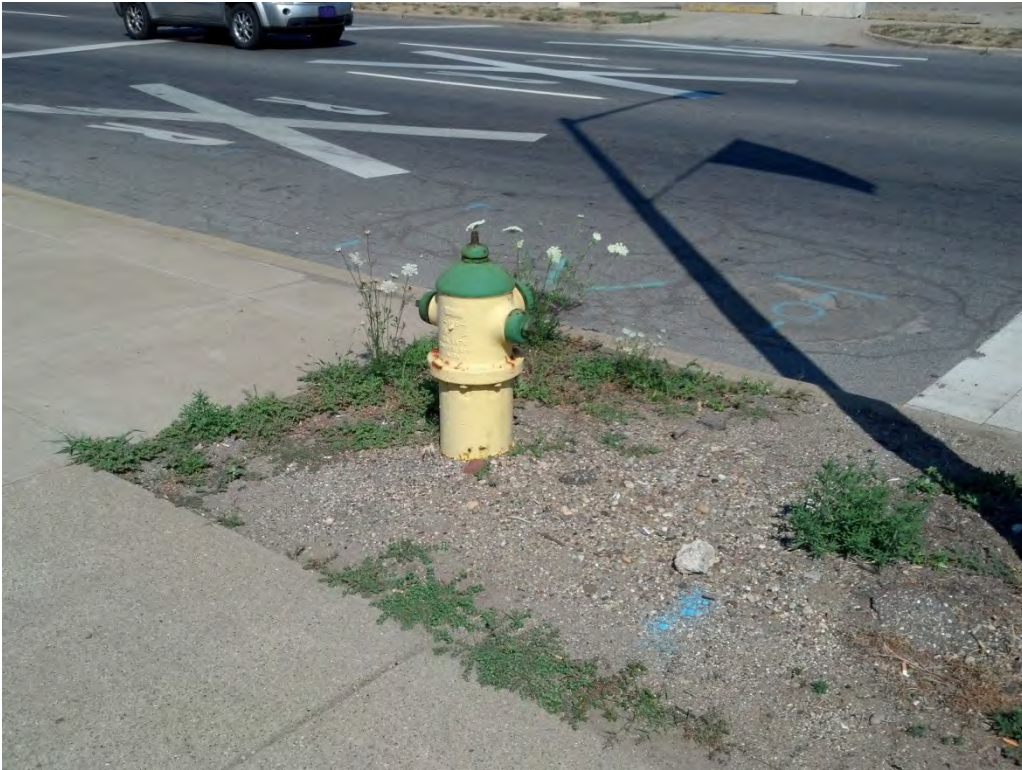
- The fire hydrant is in fair condition, with paint flaking and minor surface corrosion.

View of hydrant looking north toward East Michigan Avenue

- The hydrant should be identified/protected with construction fencing or similar during the work.

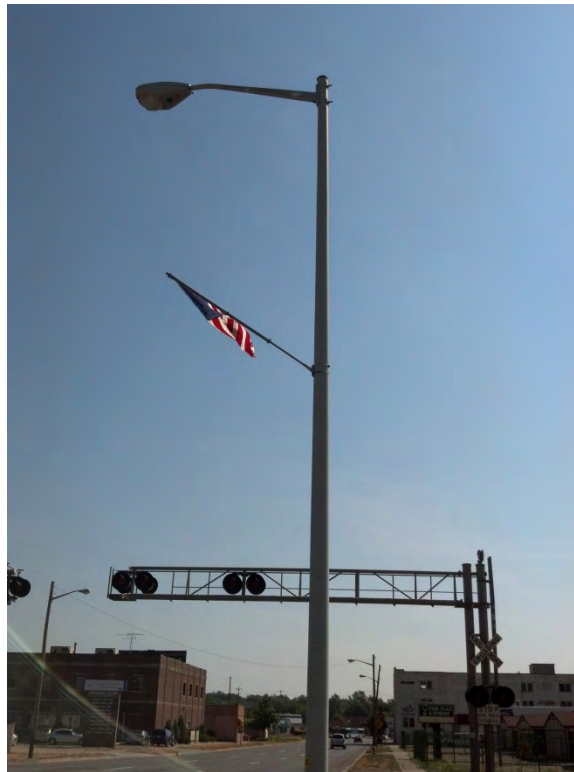
- The pole has minor graffiti but otherwise appears to be in good condition.

View of pole looking east

- The pole should be identified/protected with construction fencing or similar during the work.

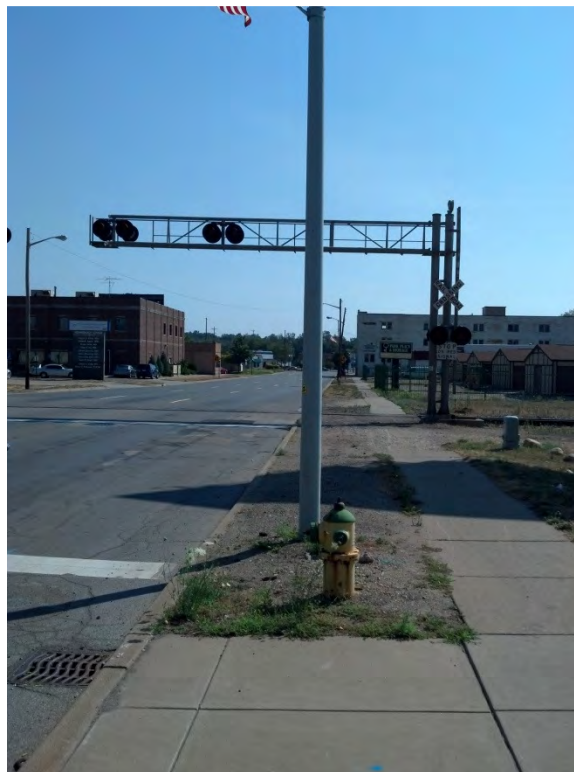
View of pole looking east showing relation to hydrant and east railroad tracks

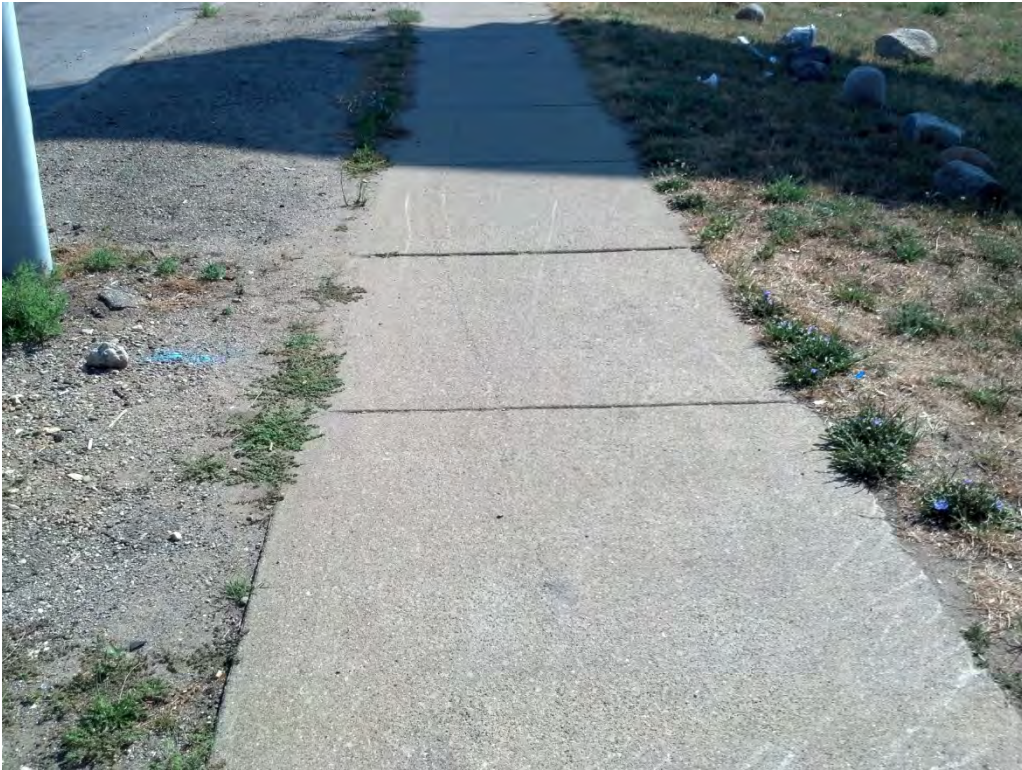
- The east flag and 3<sup>rd</sup> from east flag of concrete have moderate cracking.

View of sidewalk looking east

- The existing sidewalk is likely not intended for trucking loads and will likely crack and spall during the work. Damaged sections should be removed and replaced in kind.

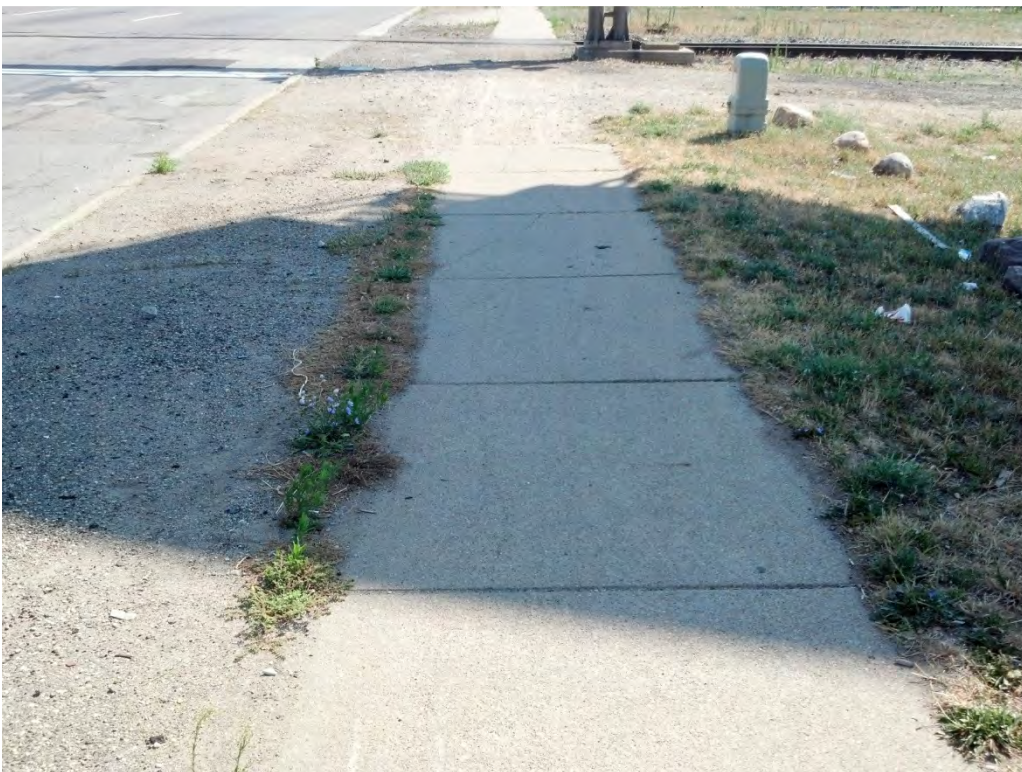
View of sidewalk looking east showing relation to hydrant and east railroad tracks
